A TO Z INSPECTIONS LLC

A TO Z INSPECTIONS GENERAL

1234 Main Street Eau Claire, WI 54701

Buyer Name 06/06/2024 9:00AM

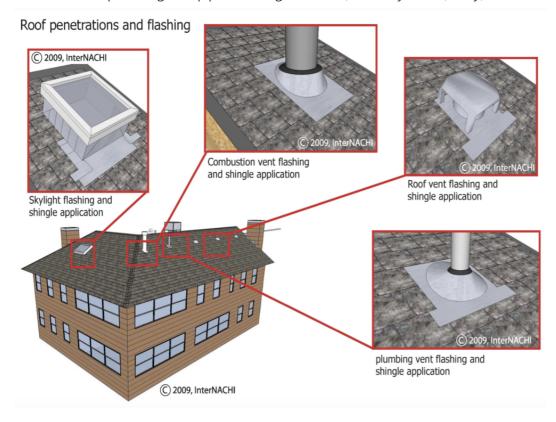
Plumbing Vent Pipes: Plumbing Vent Pipes Inspected

I looked at DWV (drain, waste and vent) pipes that pass through the roof covering. There should be watertight flashing (often black rubber material) installed around the vent pipes. These plumbing vent pipes should extend far enough above the roof surface.

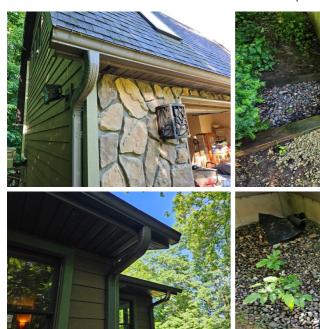
I inspected the gutters. I wasn't able to inspect every inch of every gutter. But I attempted to check the overall general condition of the gutters during the inspection and look for indications of major defects.

Monitoring the gutters during a heavy rain (without lightening) is recommended. In general, the gutters should catch rain water and direct the water towards downspouts that discharge the water away from the house foundation.

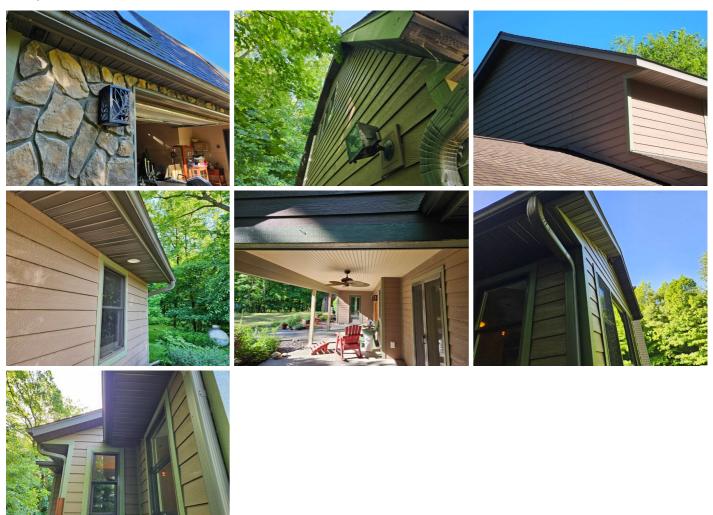
Eaves, Soffits & Fascia: Eaves, Soffits and Fascia Were Inspected

I inspected the eaves, soffits and fascia. I was not able to inspect every detail, since a home inspection is limited in its scope.

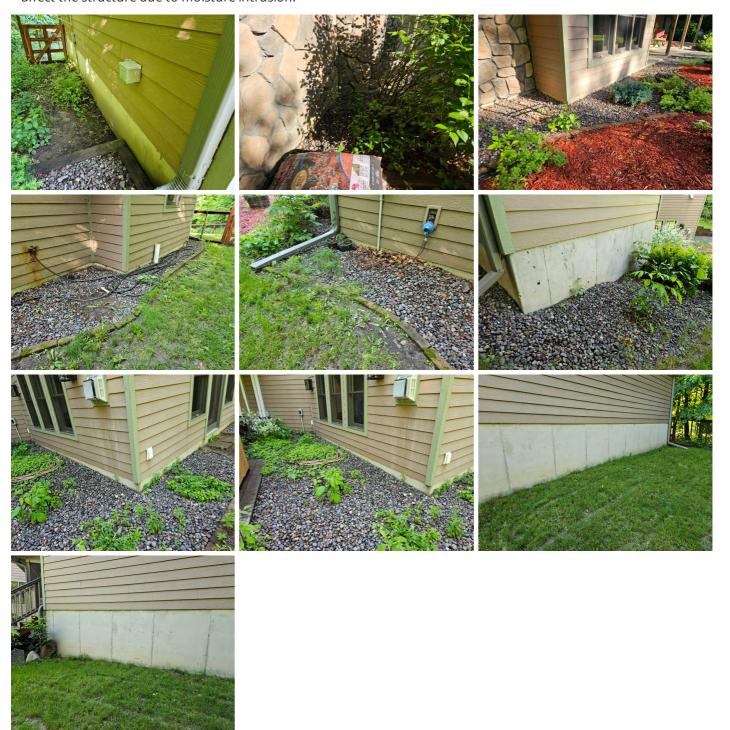
Vegetation, Surface Drainage, Retaining Walls & Grading: Vegetation, Drainage, Walls & Grading Were Inspected

I inspected the vegetation, surface drainage, retaining walls and grading of the property, where they may adversely affect the structure due to moisture intrusion.

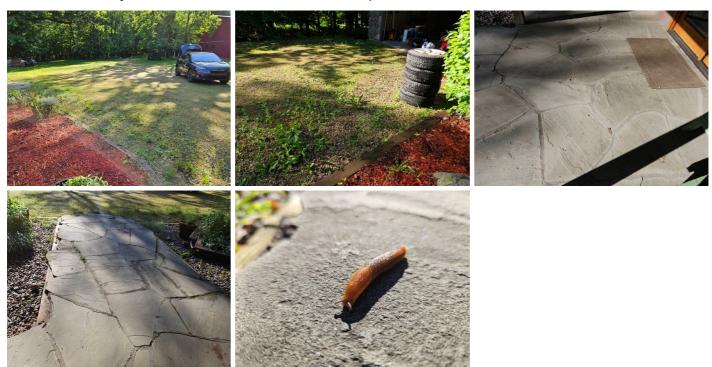
Walkways & Driveways: Walkways & Driveways Were Inspected

I inspected the walkways and driveways that were adjacent to the house. The walkways, driveways, and parking areas that were far away from the house foundation were not inspected.

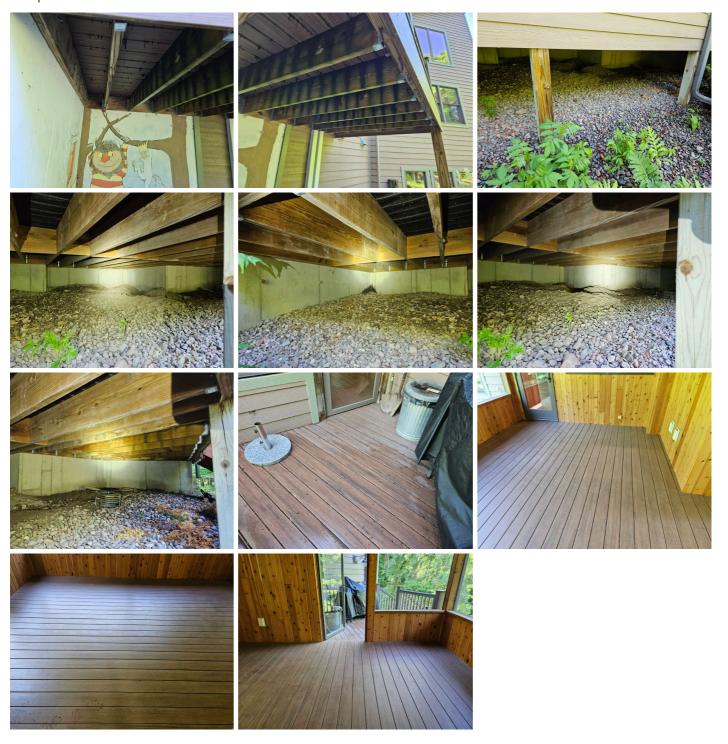
Porches, Patios, Decks, Balconies & Carports: Porches, Patios, Decks, Balconies & Carports Were Inspected

I inspected the porches, patios, decks, balconies and carports at the house that were within the scope of the home inspection.

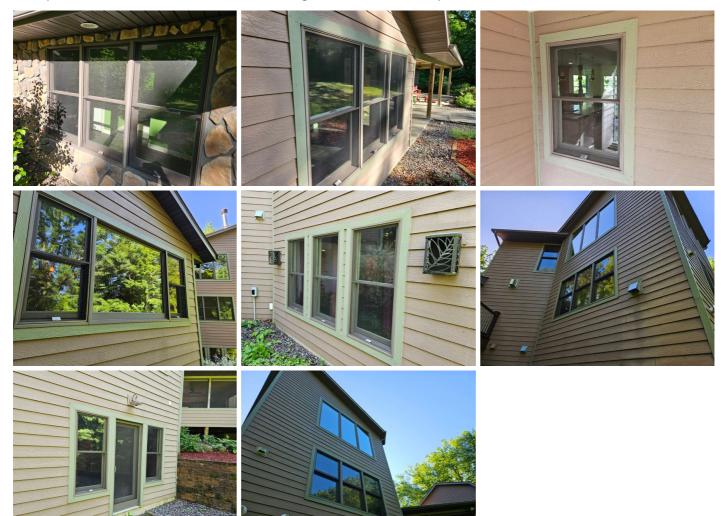
Windows: Windows Inspected

A representative number of windows from the ground surface was inspected.

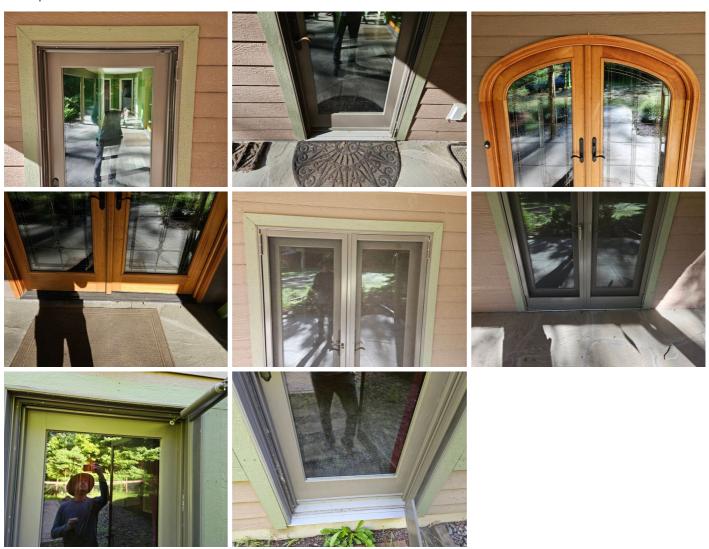
Exterior Doors: Exterior Doors Inspected

I inspected the exterior doors.

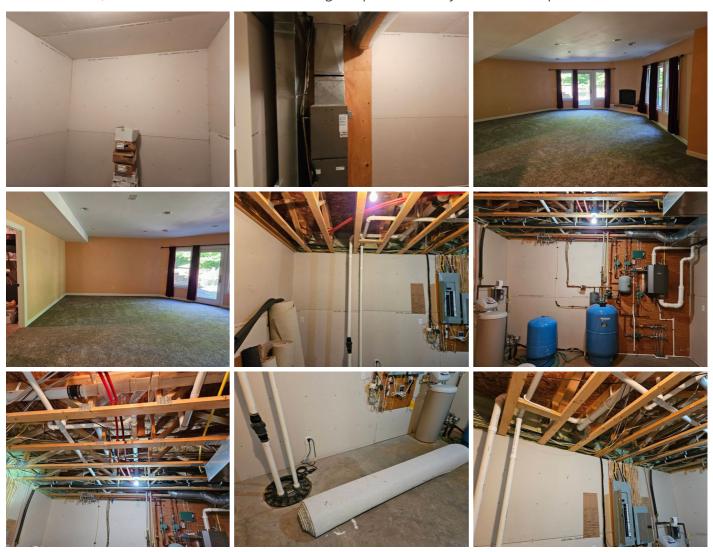
The basement was inspected according to the Home Inspection Standards of Practice.

The basement can be a revealing area in the house and often provides a general picture of how the entire structure works. In most basements, the structure is exposed overhead, as are the HVAC distribution system, plumbing supply and DWV lines, and the electrical branch-circuit wiring. I inspected those systems and components.

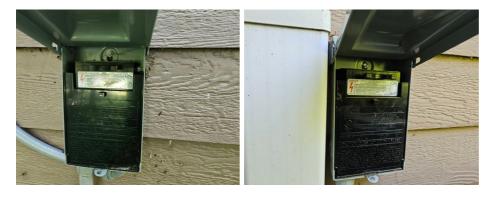
Cooling System Information: Service Disconnect Inspected

I observed a service disconnect within sight of the cooling system.

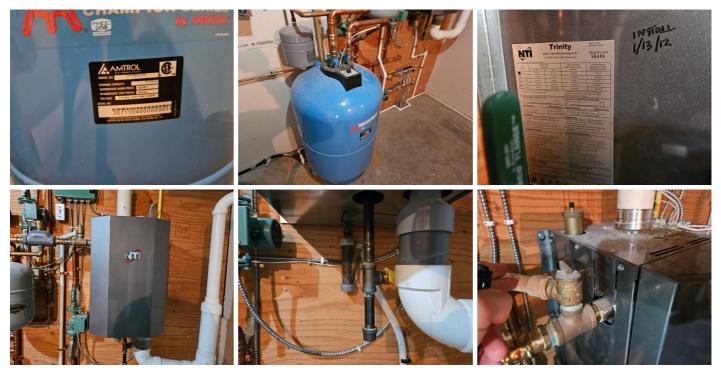
Hot Water from Boiler

I inspected for the main source of the distributed hot water to the plumbing fixtures (sinks, tubs, showers). I recommend asking the homeowner for details about the hot water equipment and past performance.

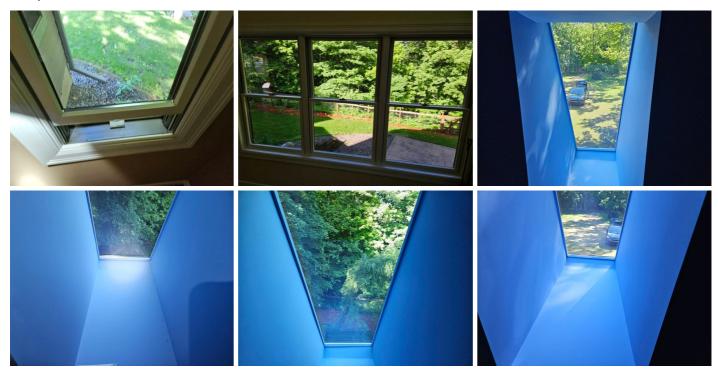
Windows: Windows Inspected

I inspected a representative number of windows according to the Home Inspection Standards of Practice by opening and closing them. I did not operate window locks and operation features, which is beyond the scope of a home inspection.
